DIVISION OF MINES AND GEOLOGY

March 12, 1998

RE: Preliminary Engineering Geologic Evaluation of Access Road Damage Weott
Community Services District, Weott, Humboldt County, California

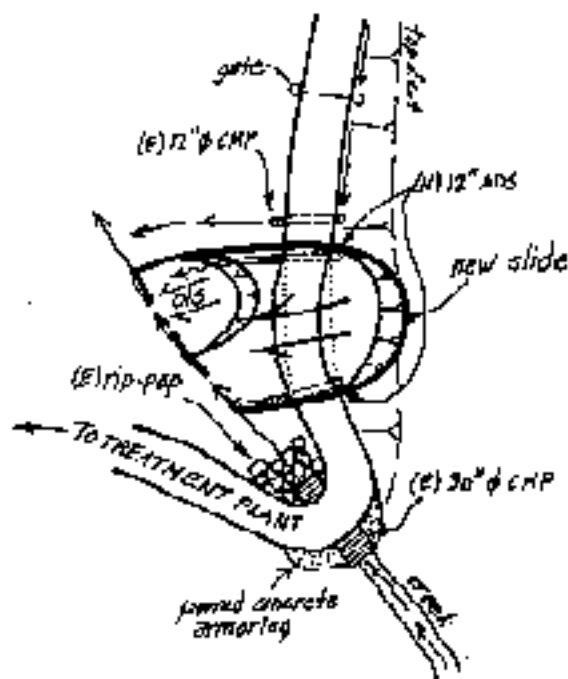
Site Map A

Site A. A rotational slump has occurred on the treatment plant access road near a crossing on an unnamed ephemeral drainage (see Figure 2). This road also provides access to a residence near the plant. The slump is approximately 50 to 55 feet wide, 80 to 90 feet long, and 15 to 20 feet deep. The existing road has been offset approximately 5 to 6 feet laterally and 2 feet vertically. A small older rotational slump is present next to the creek below the road at the northern boundary of the slump (see Figure 2).

The access road crosses near the center of the new slump using cut and fill construction, and may have inadvertently made the slope more susceptible to failure. The older slump feature below the road may have been caused by creek erosion undercutting the toe of the slope. This could also have occurred in the case of the

recent failure, but it was not obvious because dense slash and woody debris were present in the channel at the toe of the slump.

The roadway was most recently repaired (approximately one week prior to this site visit) by placing compacted gravel fill on the dropped section to bring it back up to grade. This probably added more driving force to the slump, aiding its reactivation after the initial movement. Two 12-inch diameter plastic pipes have been added to the inside ditch at the lateral margins of the slide to improve drainage on the dropped section. These were functioning during the site visit.

An existing 30-inch diameter corrugated metal culvert is in place at the inlet of the watercourse crossing and appears to have been installed when the inlet armoring concrete was placed. The remainder uses sections of pre-cast concrete culvert. Most of these have settled out of alignment and water appears to be flowing through the gaps.

The crossing was overtopped during the recent storms. However, the roadway pavement and armoring of the inlet and outlet has worked very well, allowing only minor erosion at the crossing. The District wishes to keep the existing pipe in place.

Site A. The recent slide did not appear to be a reactivated landslide. The access road appeared to have been built using a combination of cut and fill. This may have altered slope equilibrium and made the slope more susceptible to failure during wet weather.

Site A. New fill should not be placed on the sunken section of roadway as before. Any fill placed on this portion of the slump will add driving force, placing it closer to the conditions required for renewed movement. Instead, the dropped section of the roadway can be used as the new running surface. Ramps should be excavated outward in both directions from the dropped section up to the level of the existing road.

Road runoff should be intercepted before it is able to drain onto the section of the road crossing the slide. The section of roadway on the slide should be dipped and outsloped so it will naturally drain and will not collect water.

Site A Watercourse Crossing. The pipe under the road appears to be in poor condition and can be expected to fail in the near future. The existing pipe should be removed and upgraded to a larger diameter continuous pipe.

If the same pipe diameter must be used, the inlet should be mitered to improve the flow capacity. A vertical stand pipe may also be added near the inlet in order to act as an air siphon. This will also help increase the flow capacity even when the inlet is completely submerged.

Site A. Several long-term solutions should be evaluated once the weather has improved and the site is stable. These concepts should be evaluated and designed by a licensed Civil Engineer working with a certified Engineering Geologist prior to any construction.

1. Light Weight Fill. Remove the section of the slump directly under the roadway footprint and replace it with a light weight fill. In this way, a significant portion of the slump will be removed, greatly lessening the driving force in the feature.

2. Such a fill should extend down to bedrock and be constructed using wood chips, sawdust, or other "hog fuel". It is critical that the new fill be kept dry and well-drained, otherwise it will decay and settle excessively. This can be accomplished using a french drain. When installed properly, such repairs can last many decades. References can be provided as needed.

3. Engineered Fill. Remove/recompact the slide mass as a compacted engineered fill with appropriate subdrainage. Armor the toe of the new structure against creek erosion.

4. Retaining Wall. Leave slump in place. Install a french drain along uphill side of road. The french drain should extend to bedrock in order to intercept ground water. Design a structure to retain the toe.

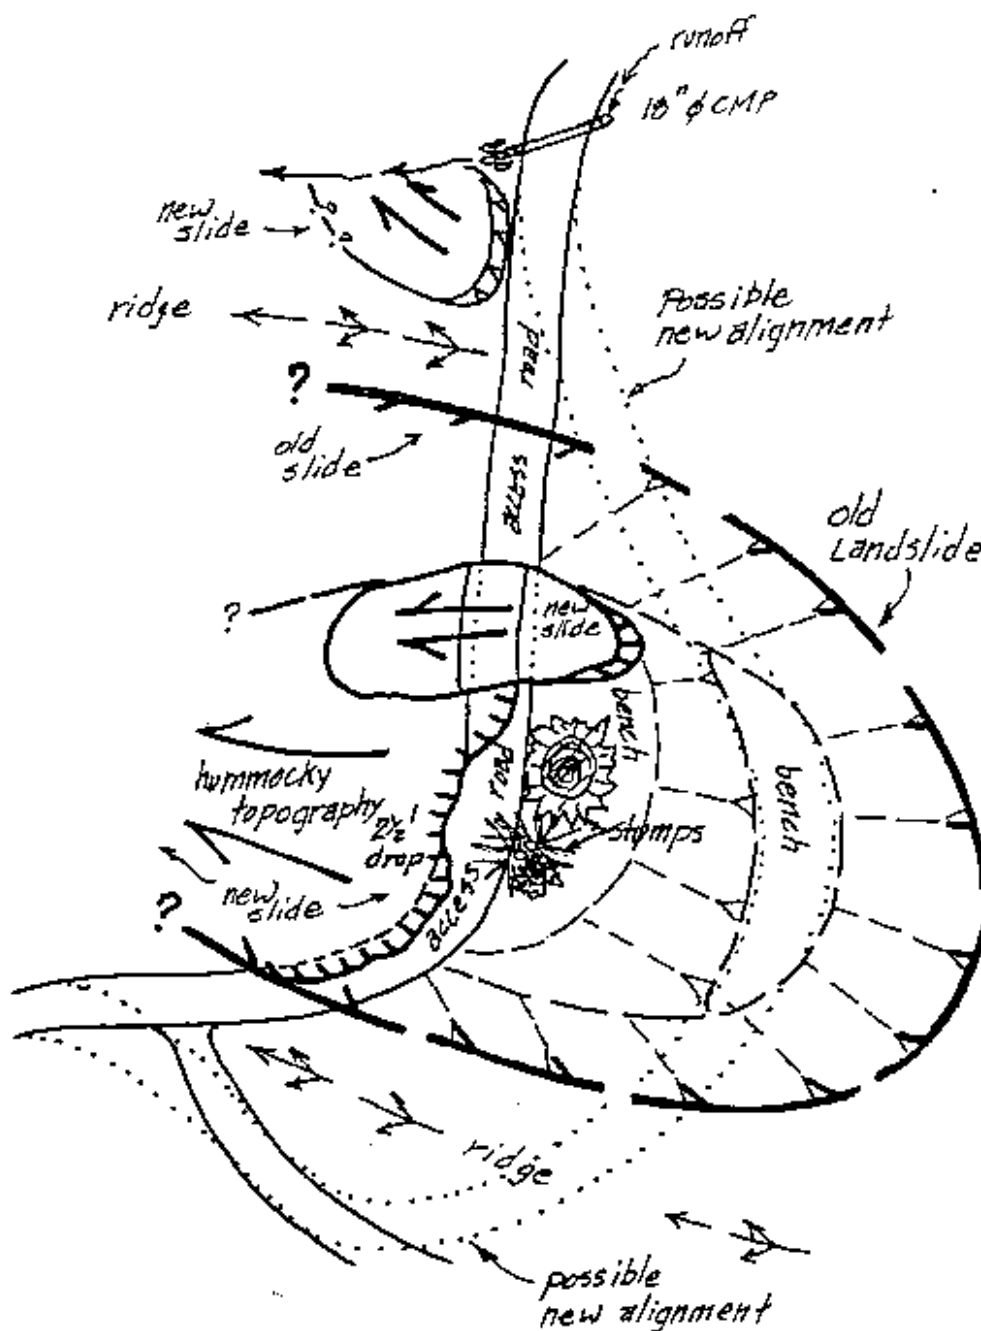
Site Map B

Site B. The second feature is located above town along a road to the District water tank (see Figure 1). The road also provides access to numerous residences. Many of the houses are heated by tanked propane which must be delivered by truck. The road crosses an old slide complex, a portion of which has been reactivated (see Figure 3). The larger slide reflects several periods of rotational slumping along with earthflow activity below the road.

The old landslide is approximately 170 feet wide, 500 to 600 feet long, and probably 50 to 80 feet deep. The active portion appears to have two sections (see Figure 3). The northern part is approximately 30 feet wide, 60 to 80 feet long and 10 to 15 feet deep. The roadway has dropped 3 to 5 feet here. A ramp was under construction leading down into the dropped section. The southern section has been largely modified by grading. It appears to continue along the roadway approximately 100 feet and the road appears to have dropped 1 to 3 feet. Only minor offset was present at the southern lateral margin. Abundant ground water was flowing out of the road cut within the active portions of the slide.

A second small landslide was noted along the outer edge of the access road approximately 100 feet north of the recent sliding. The slide is on the far side of a resistant ridge and is approximately 40 feet wide, 10 to 15 feet deep, and 50 to 60 feet long. There is a 5 foot drop down to the unit surface of this slide. An 18-inch diameter corrugated metal culvert discharges onto a rip-rap energy dissipator at the head of a small gully adjacent to the small slide, but recent high flows in the channel appear to have eroded the toe of the slope. Additional movement can be expected as the toe continues to be eroded.

Site B. The orientation and drainage of the roadway appears to be appropriate given the site conditions. The slide appears to have been moving for a long period of time, and the roadway itself probably has had little effect on the long-term behavior of the slide.

Site B. The current grading appears to be the only viable alternative at this location until better weather prevails and the slide can be carefully evaluated. Adding fill to make a ramp down onto the slide is normally not the preferred solution, but excavating a ramp up out of the slide as recommended at Site A would make the resultant roadway too steep for conventional vehicular traffic.

Site B. This site will probably never be fully mitigatable given the extent of the slide and the District's limited resources. However several limited mitigation concepts are presented for consideration. As before, these concepts should be evaluated by a licensed Civil Engineer working with a certified Engineering Geologist.

1. Subsurface Drainage System. This should be considered as a means of slowing the slides' rate of movement by removing water from the old slide mass. The roadway could then be repaired and regraded as needed. It should be noted that slow movement of the slide will eventually damage the drainage system to the point where it will stop functioning. Accelerated movement could recur. Periodic reinstallation of the drainage system should be expected in order to maintain the effectiveness of this concept.

2. Subsurface Drainage System and Roadway Realignment. A broad bench in the slide mass is located uphill of the current roadway and could be used as a new alignment. The road could then be continued farther to the south by excavating a through-cut in the stable ridgeline and connecting it with an existing driveway on the far side. A subsurface drainage system should be installed to remove ground water and improve the stability of the slide mass. The old roadway should be abandoned and regraded to make it impassable to traffic. This will improve the surface drainage in this part of the slide. It is important to note that this concept does not take into account the numerous ownerships the new road would have to cross.

Small Slide. The small slide north of the main road problem will probably continue to propagate upslope into the road unless the toe is armored against continued gully erosion. This will probably require an additional 50 to 70 feet of rock armoring in the channel. The District should also consider installing an additional culvert uphill from this one as a means of reducing the amount of runoff delivered to this drainage.
